Manhole Inspection Summary

Manhole # S67U__001MH

Location Address: **6200 Seaforth St.**

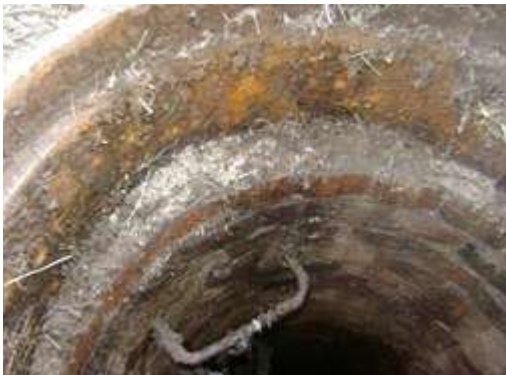
Defect 1

Offset: **2** (in.)

Offset frame defect.

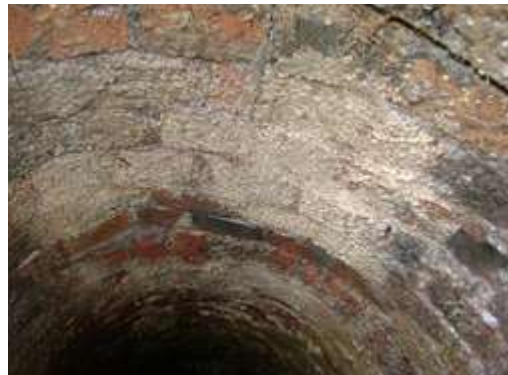
Defect 2

Condition: ☐ Sound ☐ Cracked ☒ Root Intrusion ☒ Loose Brick ☒ Deteriorated

roots sneaking in under frame in top of photo

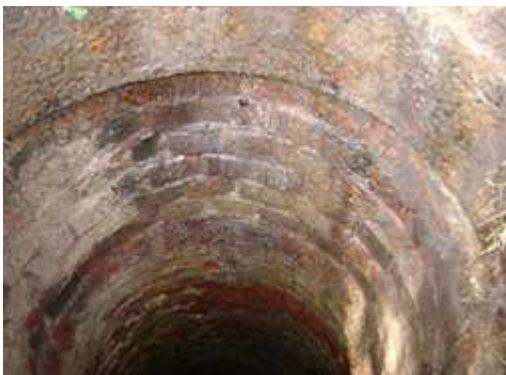
Defect 3

Infiltration: ☐ None ☒ Joint ☐ Cracks ☒ Mortar ☐ Roots ☐ Wall

Infiltration at frame seal

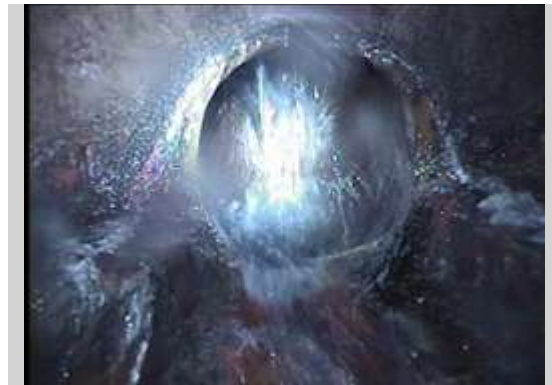
Drop In @ 3 O'Clock

Drop: **Outside** Rod and Bar
Angled: **Yes** Reading: **15.17** (ft.)
Inv Depth: **16.17** (ft.)
Drop Condition: **Partly Clogged**
